BRE Global Client Report

BS 8414-1:2015 + A1:2017 test referred to as DCLG test 1.

Prepared for: DCLG

Report Number: B137611-1037 (DCLG test 1) Issue: 1.0

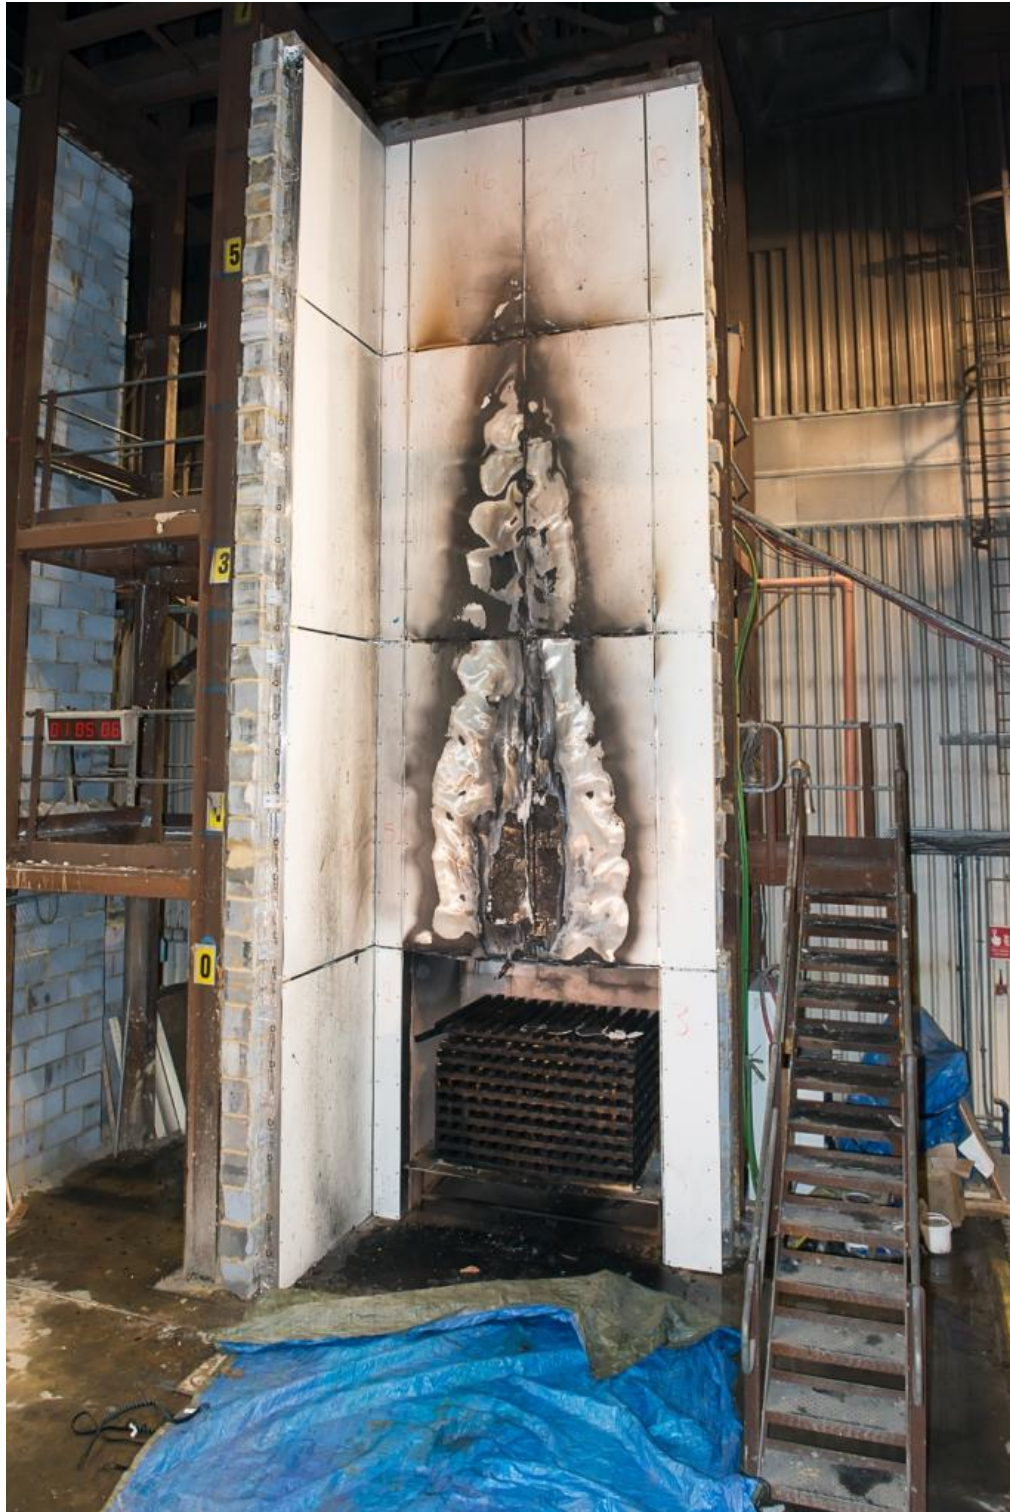
The surface finish of the panel was burnt away revealing a shiny metallic surface in a 300mm-wide strip adjacent to the consumed areas of the ACM panel which increased to approximately 1000mm at the tip of the flame impingement zone. Adjacent to the 'metallic' strip, a strip of dark discolouration, approximately 100mm-wide, which increased to approximately 1000mm at the tip of the flame impingement zone, extended to a height of 5000mm above the combustion chamber – see *Figure 21*.

Figure 21. Full height photograph of system soon after test termination.

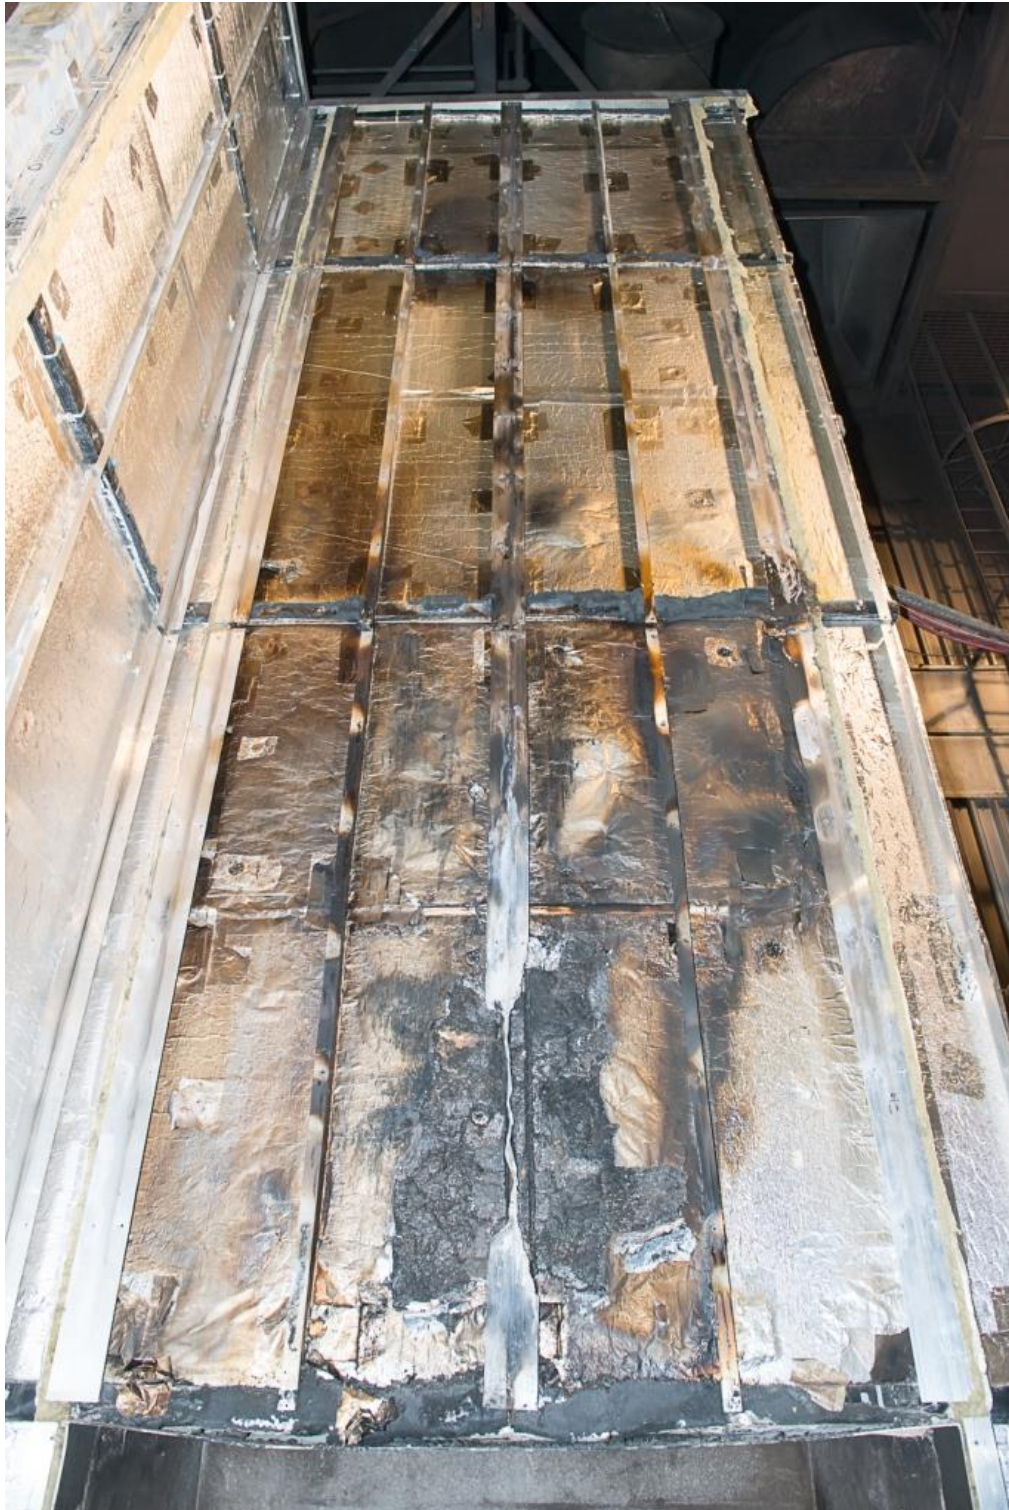
The outermost face of the central 'T' rail was absent in the region approximately 400-900mm above the top of the combustion chamber – see *Figures 27&28*. This was the only structural damage observed to the rail substructure.

The foil face on the insulation was burnt away and the insulation charred in a rectangular section approximately 600mm-wide and 1000mm-high (0.6m²) centrally located approximately 300mm above the top of the combustion chamber – see *Figure 28*.

The first row of horizontal intumescent cavity barriers directly above the combustion chamber expanded on exposure to the heat to fill the void along the majority of the combustion chamber width – see *Figure 28*.

At the second row of horizontal cavity barriers (approximately 2400mm above the combustion chamber) there was evidence of intumescent activation across the full width of the combustion chamber – see *Figure 28*. On the wing wall, directly adjacent to the main wall, a 500mm-width of the intumescent strip had partially activated – no smoke damage was visible above or below this section of cavity barrier – see *Figure 32*.

The fire damage to the ACM panels and the PIR insulation was within the bounds of the vertical cavity barriers contained within the width of the combustion chamber – see *Figure 28*. The cavity barriers suffered discolouration along the inside edges running parallel to the vertical edges of the combustion chamber.

Figure 28. Damage to cladding system beneath ACM panels directly above the combustion chamber.
